Procurement of a Line Car

Presented to: Organizational,
Services & Performance
Monitoring Committee

August 13, 2024

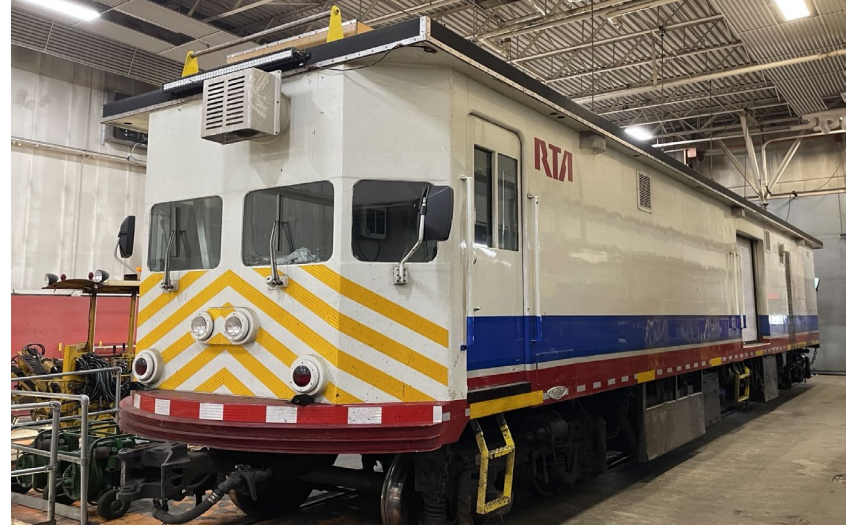
Line Car History

- Overhead Catenary Maintenance Vehicle (OCMV)
- Designated as 032, referred to as The Line Car
- Purchased from Fuji Industries in 1977
- Operated as OCMV for over 45 years.

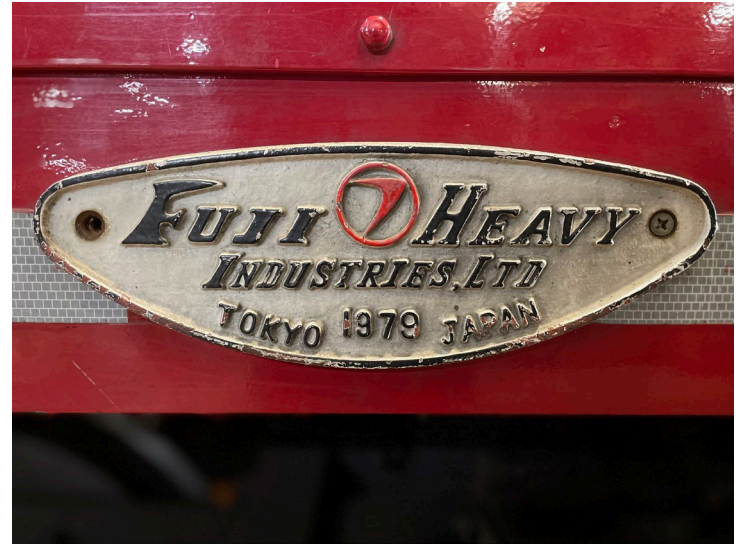
Line Car History

Engine Rebuild:

- Two during lifetime – 2017 Most recent

Roof Rebuild:

- Two during lifetime – 2023 most recent

Additional Work Necessary:

- Third engine rebuild/replacement
- AC/DC motor rebuild and generators
- Wheel truing

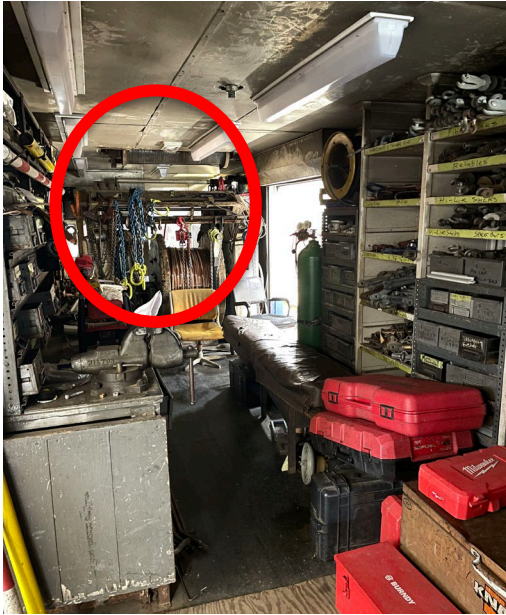
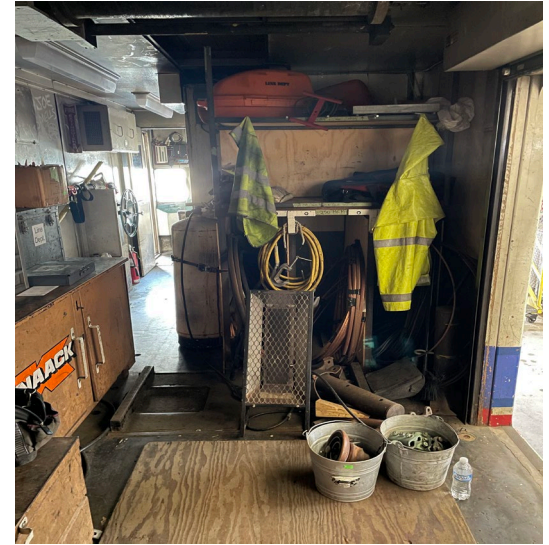
Line Car Interior

Dual Cable Reel And Storage System:

- Pay-in capabilities no longer functions as designed
- Tensioning system no longer functions as designed

Workshop:

- Limited storage space for tools, material, and PPE
- Limited seating for personnel to and from work site

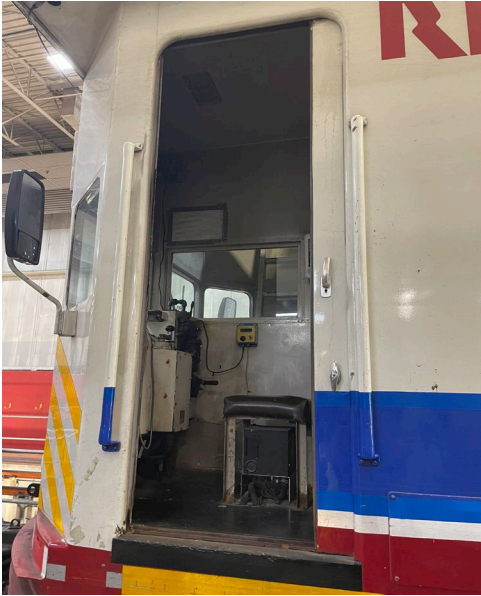
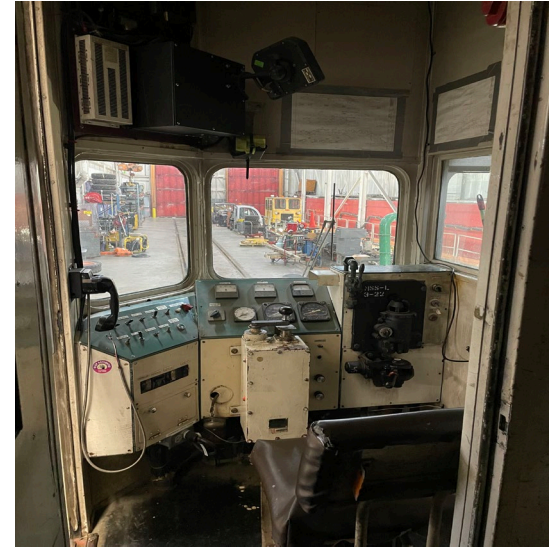
Line Car Interior

Operator Cabin and Controls:

- Operator controls not clearly labeled.
- Limited feedback from vehicle systems.
- Field of view for operator is limited.

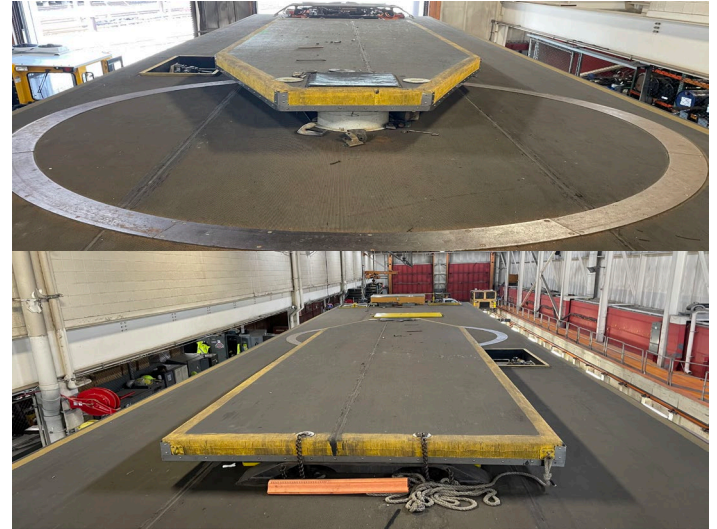
Line Car Exterior

Swiveling work platform

- Rotates 360 degrees
- Non-motorized – “self propelled”
- Utilizes wheel chocks for stability
- Lacks lifting capabilities for vertical operation beyond Line Car height.
- Lacks fall protection

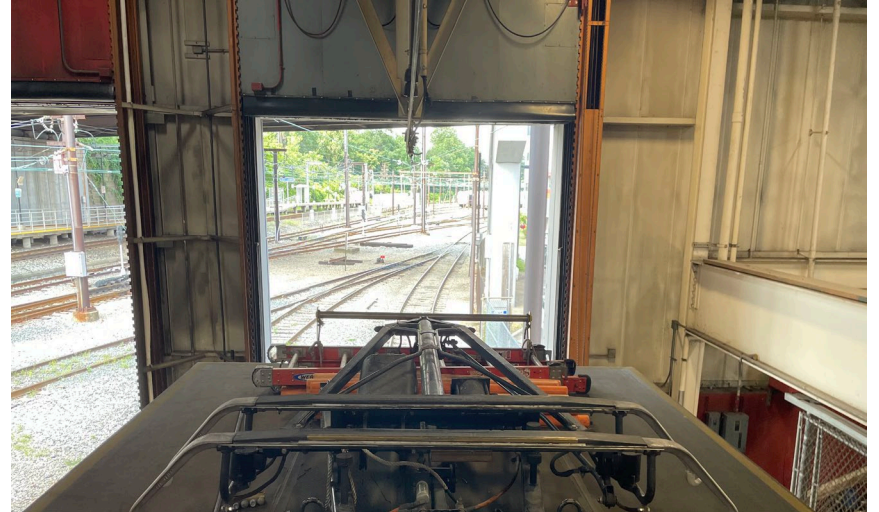
Line Car Exterior

Pantograph:

- Operational for glide check and stagger
- Simulates operating conditions for revenue vehicles

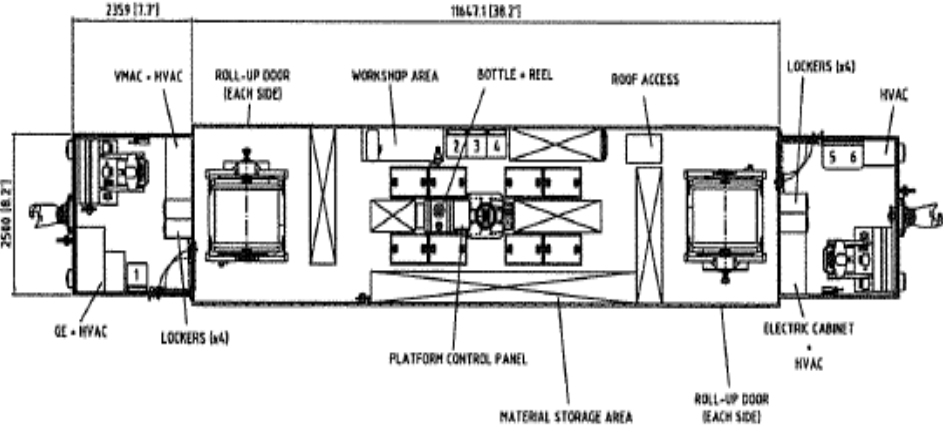
Proposed Design – Future State

- Delivery of a new OCMV for inspection, maintenance and installation of GCRTA overhead catenary systems
 - Capable of video surveillance and monitoring of OCS
 - Capable of multiple cable pay-out under tension
 - Capable of maintaining assets up to 25' in the air
 - Fall Protection

- Provide a OCMV that conforms to the new dynamic envelope of passenger stations after completion of Engineering Project 66E1
- Improved Field of vision for operator(s)
- Improved storage for tools, equipment and PPE
- Meets EPA Tier 4 diesel engine requirements
